Appendix I4

Biological Opinion & Biological Assessment

Consultation Number: 02ETAU00-2015-F-0031

RE: CSJs 0253-04-138 & 0253-04-146

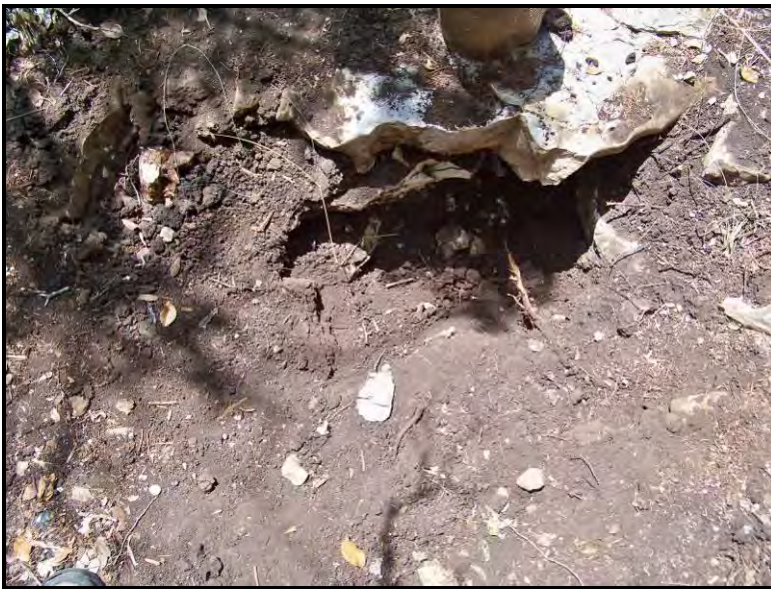
Figure 27. Feature 281-015 after excavation, showing hard-packed clay floor.

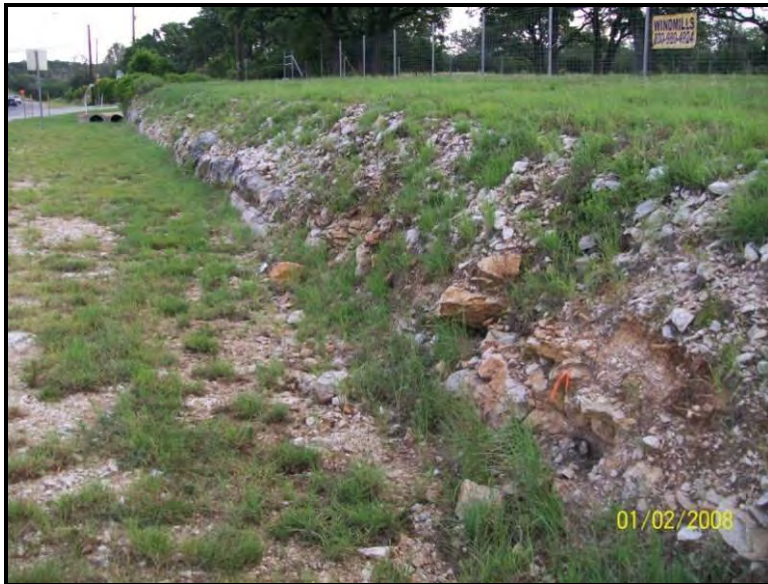
281-016, enlarged fracture This feature is located in the east road cut of US 281 (Figure 28). When initially assessed on 2 March 2010, it had an opening 0.1 m (0.3 ft) in diameter, and it split into two routes with an estimated depth of over 1 m (3.3 ft) (Figure 29). Airflow was detected, suggesting a continuation; therefore excavation of the feature was conducted. On 18 June 2010, 5 person hours of excavation effort was expended utilizing an electric chipping hammer. One cubic meter (35 ft³) of material was removed. The feature was enlarged to a width of 1.5 m (4.9 ft), with several large slabs still blocking the way. These were removed with a jackhammer on 21 June 2010 in an effort that involved 6 person hours of labor and the removal of an additional 1 m³ (35 ft³) of material (Figure 30). Post-excavation dimensions of the feature were 0.7 m (2.3 ft) long by 1.5 m (4.9 ft) wide by 1 m (3.3 ft) deep. Bedrock was reached, with no signs of a drain or karst processes. This feature was likely formed by fracturing caused by excavation of the road cut during

Figure 28. Overview of feature 281-016, marked with flagging tape in the lower right side of picture. It was probably fracturing caused during excavation of the road cut.

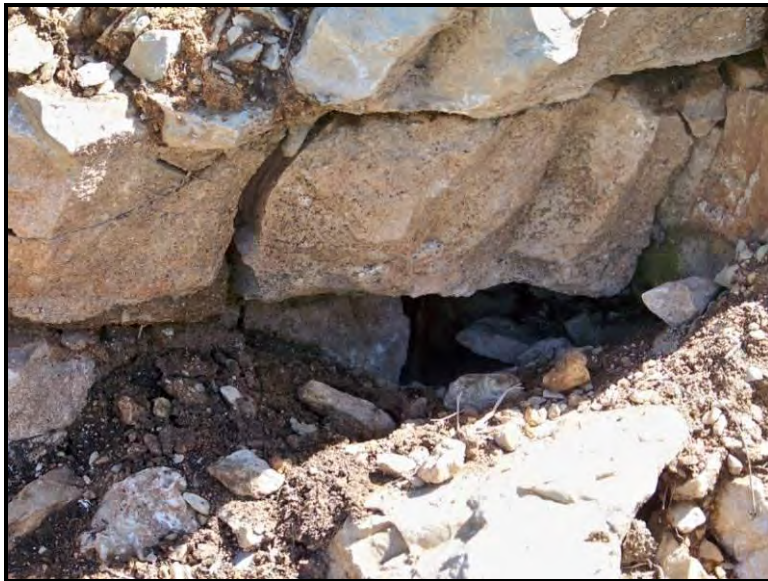
Figure 29. View of feature 281-016 prior to excavation.

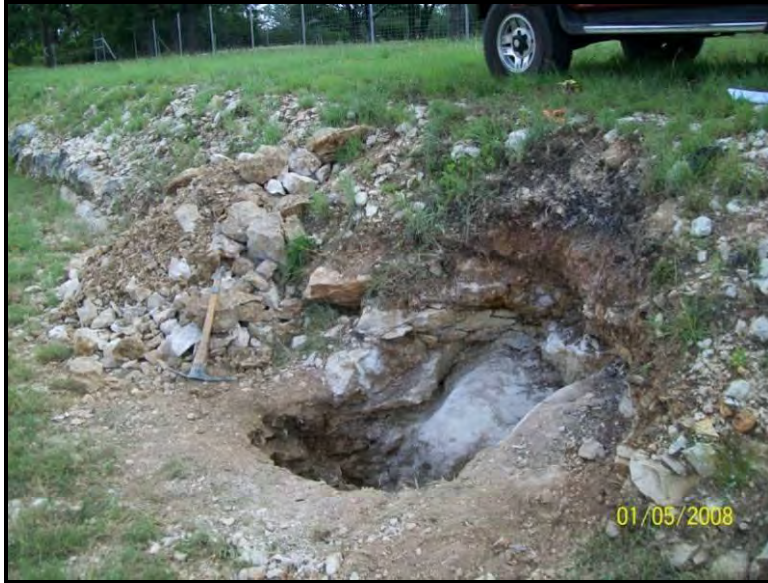
road building activities. Excavation showed that the road cut extended below the current level of bar ditch fill.

Figure 30. View of feature 281-016 after excavation. Bedrock can be seen on the right, and on the left is fill resulting from grading of the bar ditch.

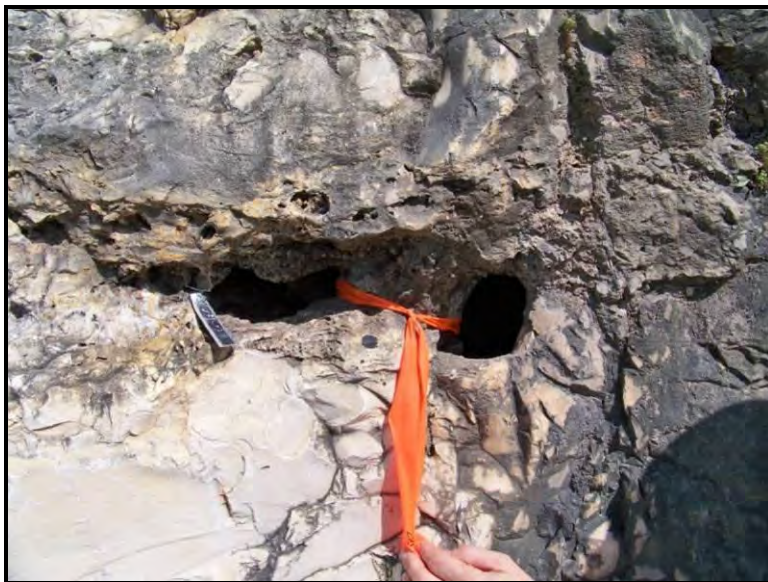
281-017, solution cavity This feature is situated in the eastern road cut of US 281. It is a solution cavity with two small entrances that are approximately 0.1 m (0.5 ft) in diameter (Figure 31). It drops vertically into the road cut for approximately 0.5 m (1.6 ft). This feature was not recommended for excavation (Table 1).

Figure 31. View of feature 281-017.

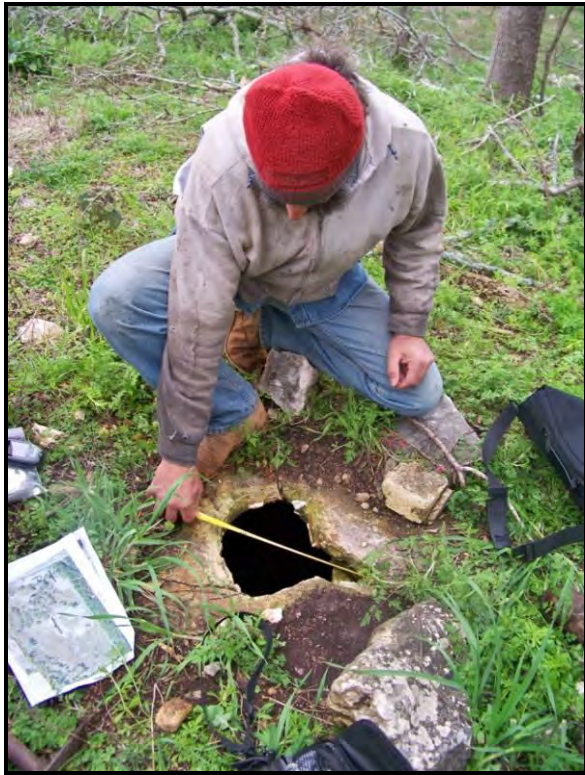
281-020, man-made feature When initially discovered, this feature was represented by nearly square shaped opening in the ground measuring 0.36 m (1.2 ft) by 0.33 m (1 ft) by

Figure 32. Overview of feature 281-020.

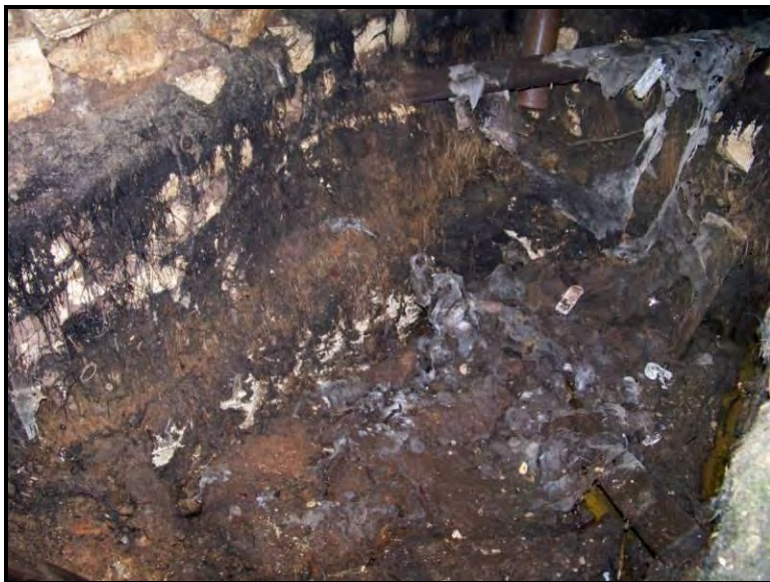
1.75 m (5.7 ft) deep (Figure 32). Photos of the interior of the feature revealed that it is an abandoned hand-dug well or cistern (Figure 33). It is not karst related.

Figure 33. Interior of feature 281-020.

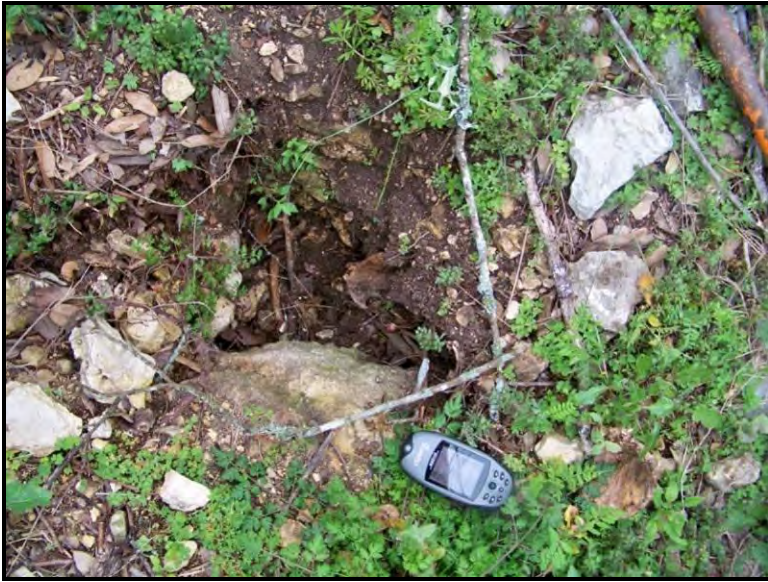
281-021, solutional sinkhole This was a solutional sinkhole that measured 0.5 m (1.6 ft) by 0.4 m (1.3 ft) across and was 0.8 m (2.6 ft) deep (Figure 34). It was in-filled with rocks and modern soils (Figure 35). It was recommended for excavation, but ROE for excavation purposes was not granted.

Figure 34. Feature 281-021 prior to brief exploratory excavation.

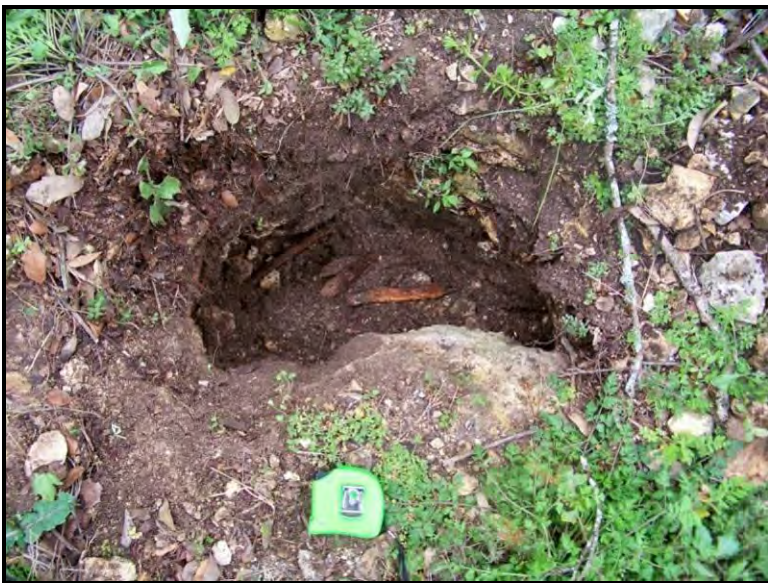
Figure 35. Feature 281-021 subsequent to removal of loose surface soil.

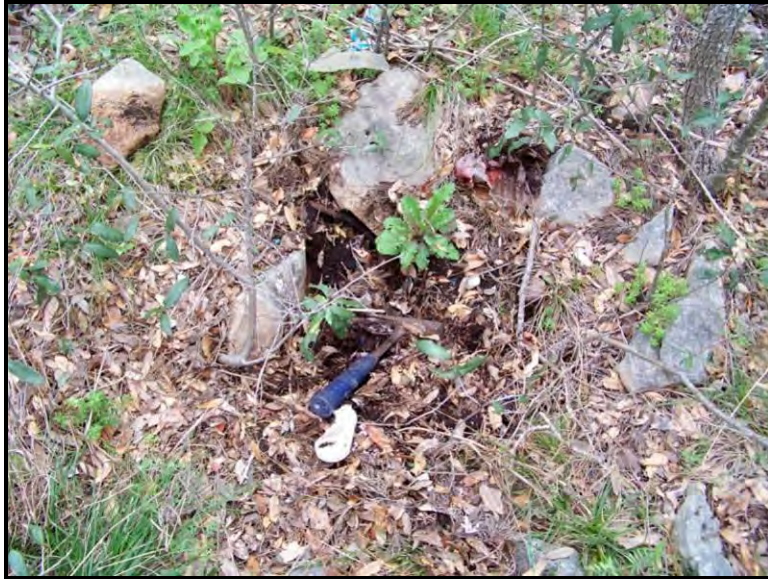
281-024, non-karst closed depression This was a depression measuring 1 m (3.3 ft) long and 0.7 m (2.3 ft) wide and 0.3 m (1 ft) deep (Figure 36). It was filled with leaf litter, modern soils, and trash. Two large rocks were removed from it during excavation on 13 August 2010. Post-excavation dimensions of this feature were unchanged. It was determined that this feature was formed by roots lifting rocks, and it is not karstic.

Figure 36. Overview of feature 281-024.

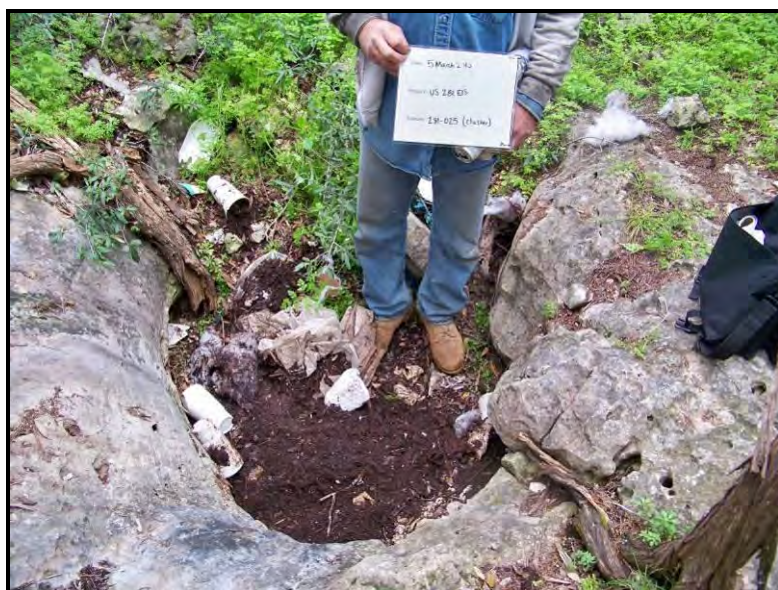
281-025, Taco Truck Tunnel, cave This is a cluster of closely spaced karst features, one of which is a cave. This cave is in a depression that measures 3 by 4 m (9.8 by 13.1 ft) across (Figure 37). One meter (3.3 ft) to the east of the cave is a solution hole that is 0.4 m (1.3 ft) in diameter. Three meters (10 ft) southeast of the cave is a solutionally-enlarged fracture that measures 0.76 by 0.91 m (2.3 by 2.5 ft), with a bearing of 137 degrees. Four meters (13 ft) to the southeast is a pair of fractures that form a cross 0.78 m (31 in) in diameter. These fractures have bearings of 77 and 167 degrees. The cave feature was recommended for excavation. Excavation took place on 13, 17, 19, 26, 27 August and 15-16 September 2010. Total excavation effort expended was 113 person hours, and 9.5 m³ (335 ft³) of soil and rocks was removed. The entrance to this cave is surrounded by sloping bedrock (Figure 38) measuring 1.8 by 1.2 m (5.9 by 3.9 ft) across. It drops 1.3 m (4.3 ft) to a ledge, followed by a 2.3 m (7.5 ft) climb-down to a dirt floor (Figure 39). A crawlway extends to the northwest for 1.5 m (4.9 ft), where the cave ends in a small dome (Figure 40). The post-excavation dimensions of the cave were 5 m (16.4 ft) long by 3.5 (11.5 ft) wide by 5 m (16.5 ft) deep. A lithic arrow point was found during soil excavations at this cave. The cave was named for a nearby dining establishment. Biological surveys on this feature were conducted on 17 and 24 September and 1 October 2010. A list of fauna encountered in 281-025 can be found in Table 6 and microclimate measurements are included in Table 7.

Figure 37. Feature 281-025 prior to excavation.

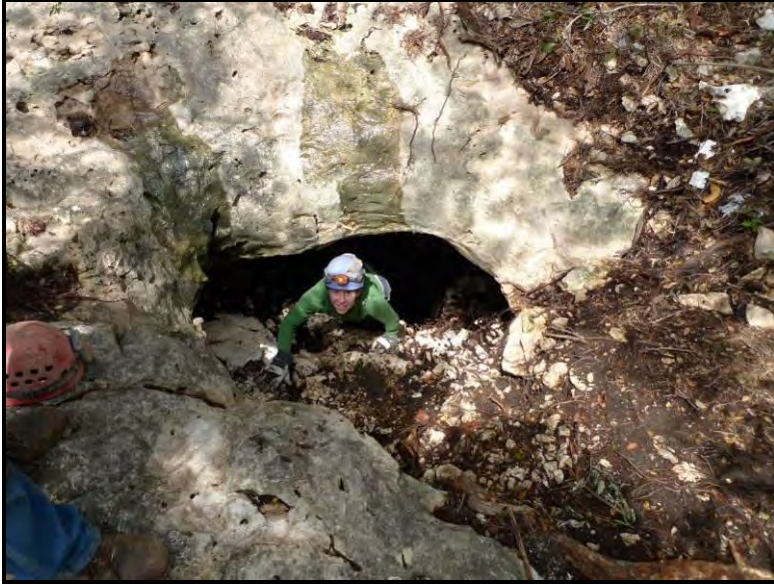
Figure 38. Entrance to feature 281-025 after excavation.

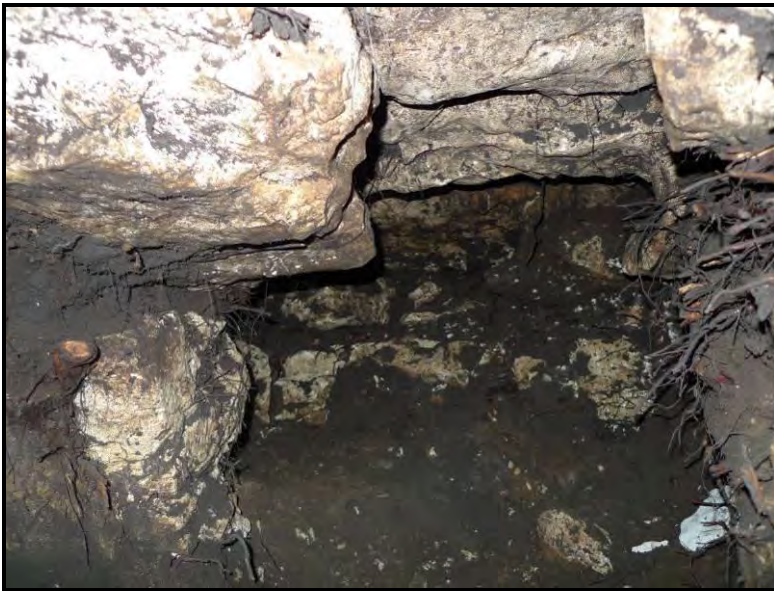
Figure 39. Bottom of feature 281-025 after excavation.

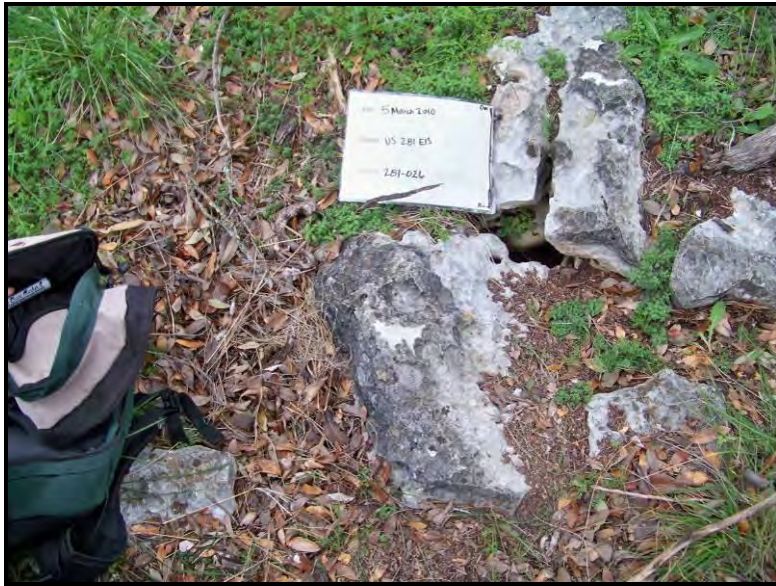
281-026, solutional sinkhole This is a solutional sinkhole that was initially 1.3 m (4.3 ft) long and 1.2 m (3.9 ft) wide. It was 0.6 m (2 ft) deep and contained leaf litter and clean-washed rocks (Figure 41). The feature is formed along a fracture trending at 45 degrees. Excavation was conducted with hand tools on 19 August and with a jackhammer on 10 September 2010. A total of 5 person hours of effort was expended, resulting in the removal of 1.3 m³ (46 ft³) of material. A bedrock floor was reached at a depth of 0.5 m (1.6 ft) (Figure 42). Lateral excavation along a bedding plane for 0.5 m (1.6 ft) revealed nothing but hard-packed clay (Figure 43). Post-excavation dimensions of the feature were 1.3 m (4.3 ft) long and 1.25 m (4.1 ft) wide and 0.6 m (2 ft) deep. A list of fauna encountered in 281-026 can be found in Table 8.

Figure 41. Overview of feature 281-026.

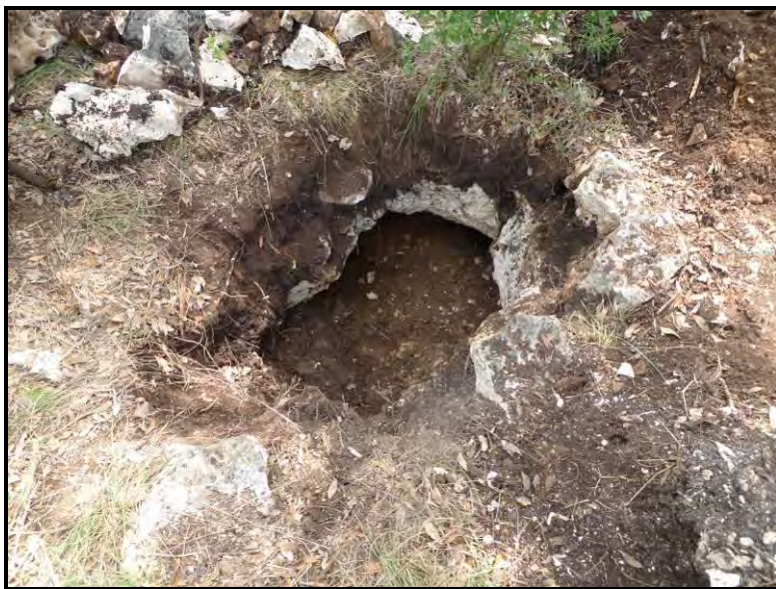
Figure 42. Overview of feature 281-026 after excavation.

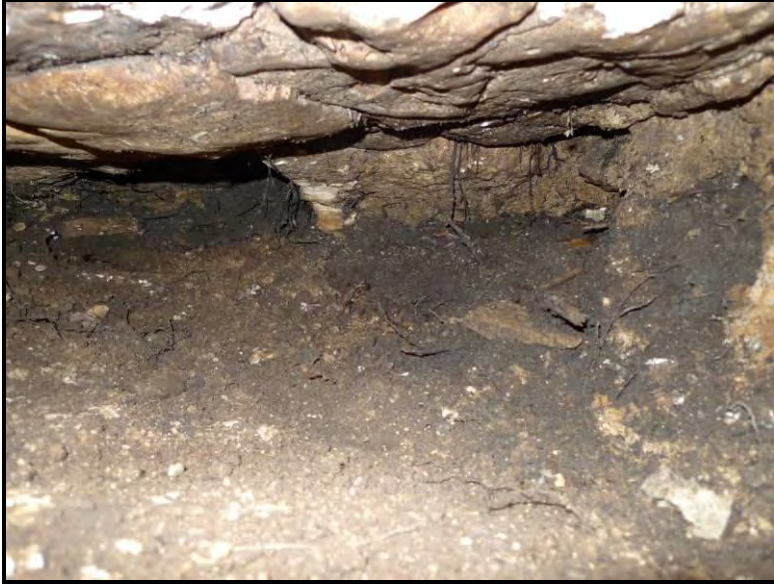
Figure 43. Interior of feature 281-026 after excavation.

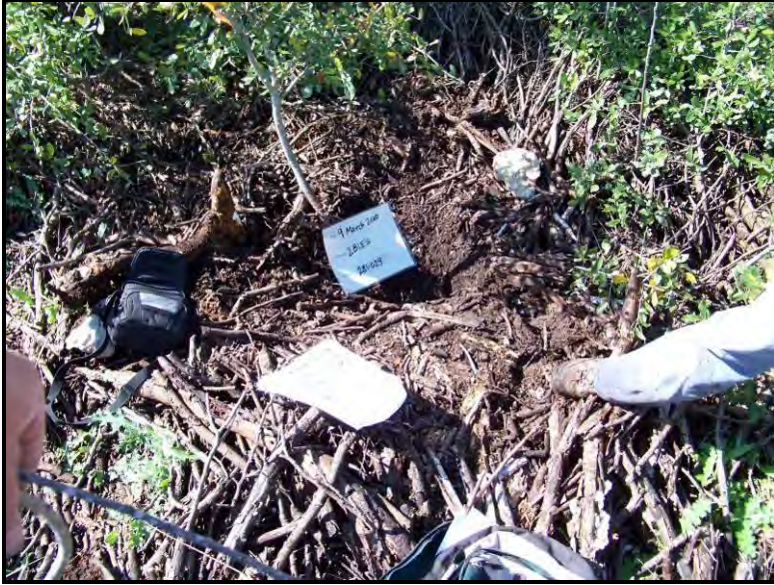
281-029, solutional sinkhole This is a depression that was initially 0.56 m (1.8 ft) long and 0.48 m (1.6 ft) wide (Figure 43). It had a noticeable drain, and contained fine infill comprised of leaf litter and black, modern soil (Figure 44). Excavation was conducted on 2 August 2010 resulted in the removal of a large rock and decaying sticks. A bottom of hard red clay was reached and no continuing drain could be seen. However, flood debris seen piled on top of the feature after a heavy rain indicates that it may have a high rate of infiltration. Post-excavation dimensions of this feature were 1 m (3.3 ft) in diameter with a depth of 0.3 m (1 ft).

Figure 44. Overview of feature 281-029.

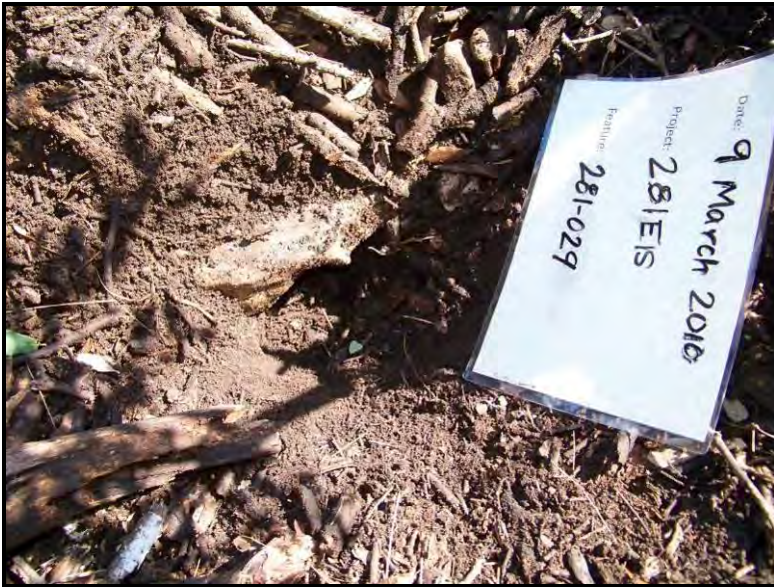
Figure 45. Close-up view of feature 281-029.

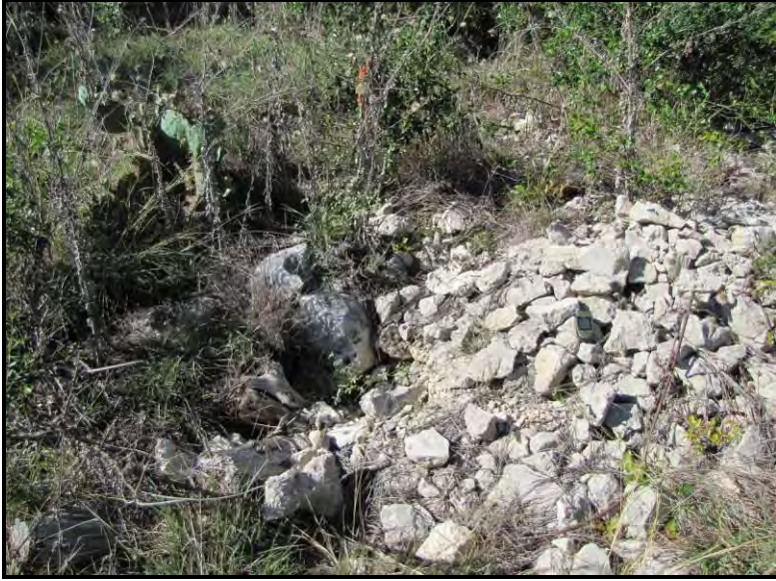
281-030, sinkhole This is a depression of undetermined origin that contains old stumps, concrete, and rocks (Figure 46). It measures 0.5 by 0.25 m (1.6 by 0.8 ft), and is 0.2 m (0.7 ft) deep. Excavation was conducted on 2 August 2010, and 1 m³ (35 ft³) of material was removed utilizing hand tools. This material consisted of chunks of concrete and juniper stumps (Figure 47). The feature was excavated to a depth of 0.75 m (2.5 ft), about 0.2 m (0.7 ft) past the black soil layer into red and white clay. No drains were found. Post-excavation dimensions of this feature were 1.25 m (4.1 ft) in diameter and 0.75 m (2.5 ft) deep. Due to previous anthropogenic activity at this site, its origin is unclear.

Figure 46. Overview of feature 281-030 prior to excavation.

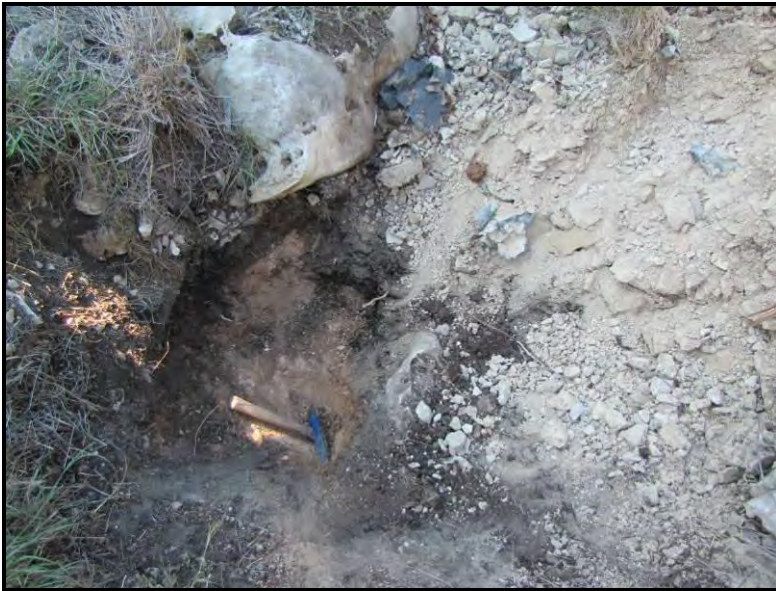
Figure 47. Feature 281-030 after excavation.

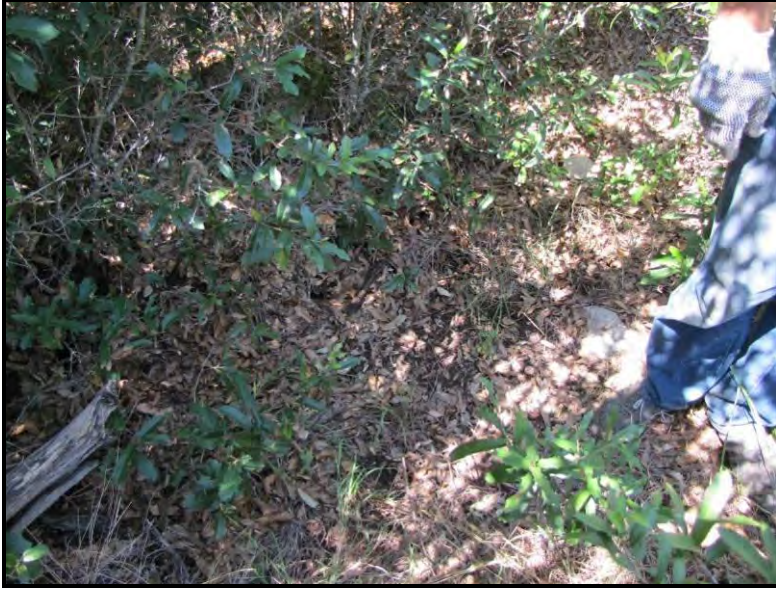
281-031, collapse sinkhole This pair of depressions within an area 3.5 m (11.5 ft) in length by 1 m (3.3 ft) wide (Figure 48 and Figure 49). They had coarse infill of modern soil and may be the result of tree removal. Excavation took place on 2 August 2010, and resulted in the removal of 0.4 m³ (14 ft³) of soil from the two depressions (Figure 50 and Figure 51). They were dug to depths of 0.3 and 0.4 m (1 and 1.3 ft) to hard packed bottoms with no drains. Post-excavation dimensions of the features were 1 m (3.3 ft) by 0.5 m (1.6 ft) by 0.4 m (1.3 ft) and 0.5 m (1.6 ft) in diameter by 0.3 m (1 ft) deep.

Figure 48. South depression at feature 281-031 prior to excavation.

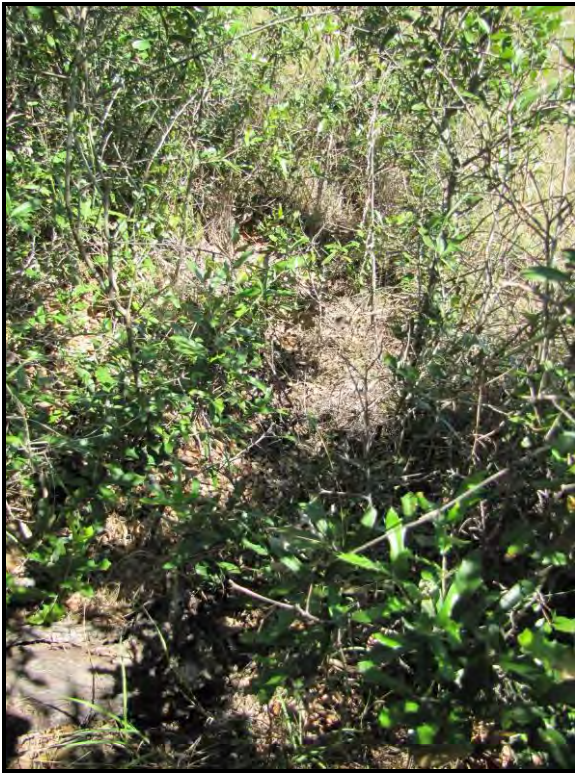
Figure 49. North depression at feature 281-031 prior to excavation.

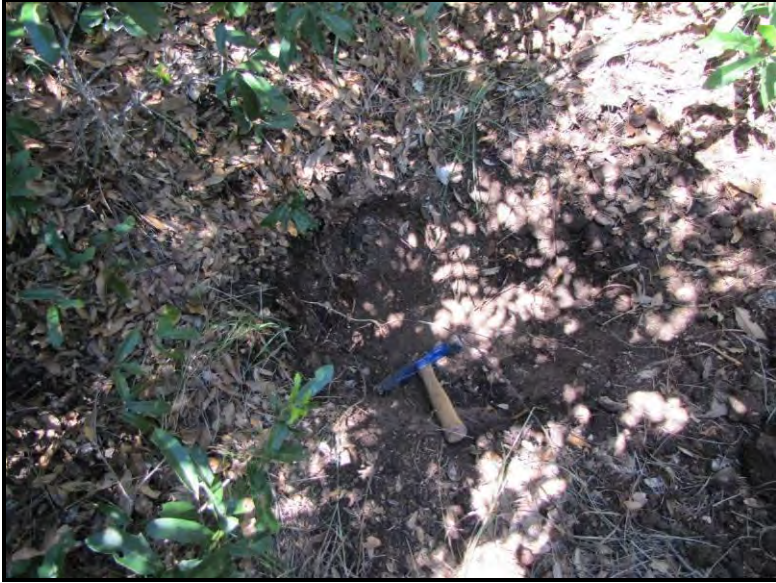
Figure 50. South depression at feature 281-031 after excavation.

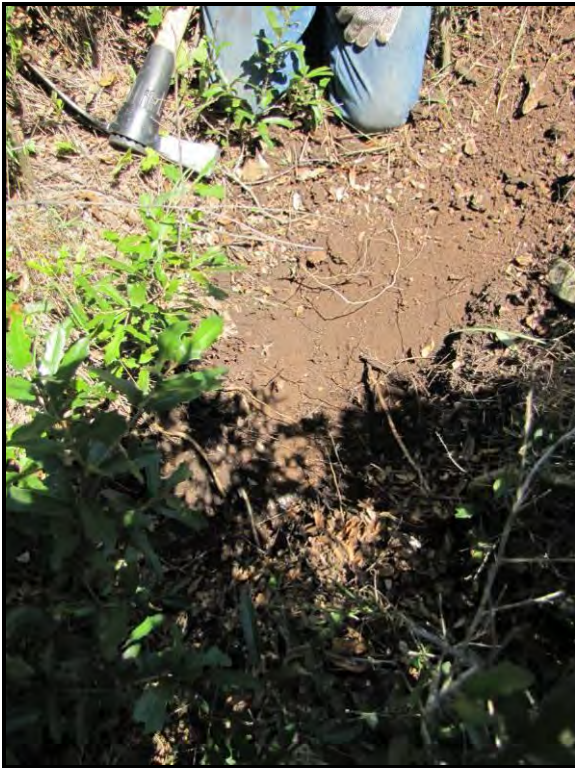
Figure 51. North depression at feature 281-031 after excavation.

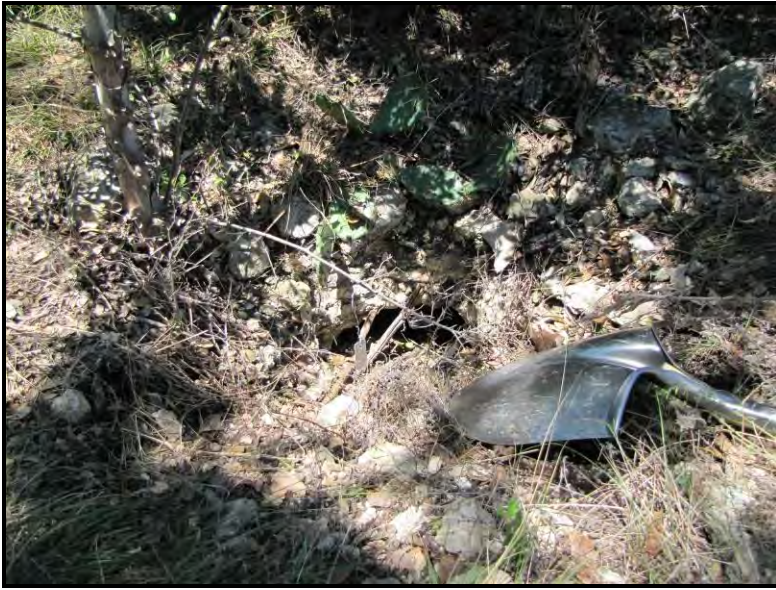
281-032, sinkhole This is a solutional or collapse sinkhole that is 1 m (3.3 ft) long and 0.8 m (2.6 m) wide (Figure 52). It receives recharge from an area measuring 3 by 5 m (9.8 by 16.4 ft). It contained infill of leaf litter and clean-washed rocks. An opossum was observed in this feature. Excavation was conducted on 2 August 2010. Black soil and rocks were removed from the floor, reaching a hard-packed bottom with no drains at a depth of 0.9 m (2.9 ft) (Figure 53). Post-excavation dimensions of the feature were 1 m (3.3 ft) in diameter and 0.9 m (2.9 ft) deep.

Figure 52. Feature 281-032 prior to excavation.

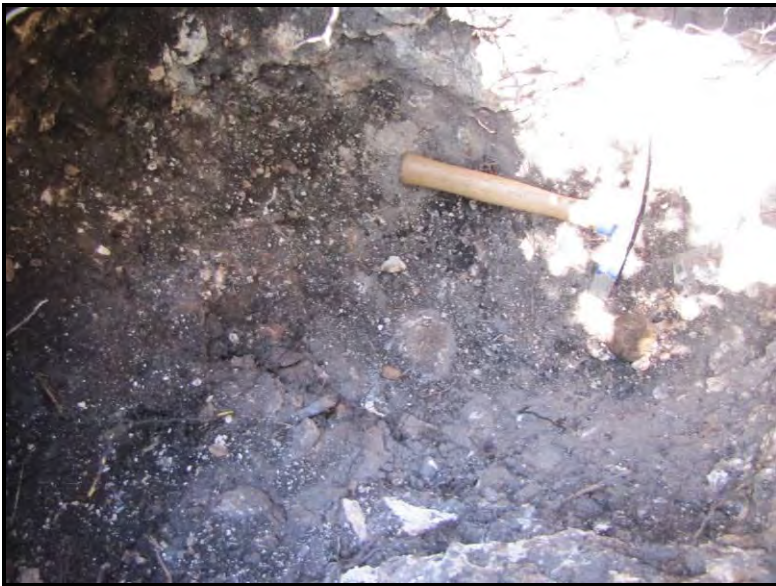
Figure 53. Feature 281-032 after excavation.

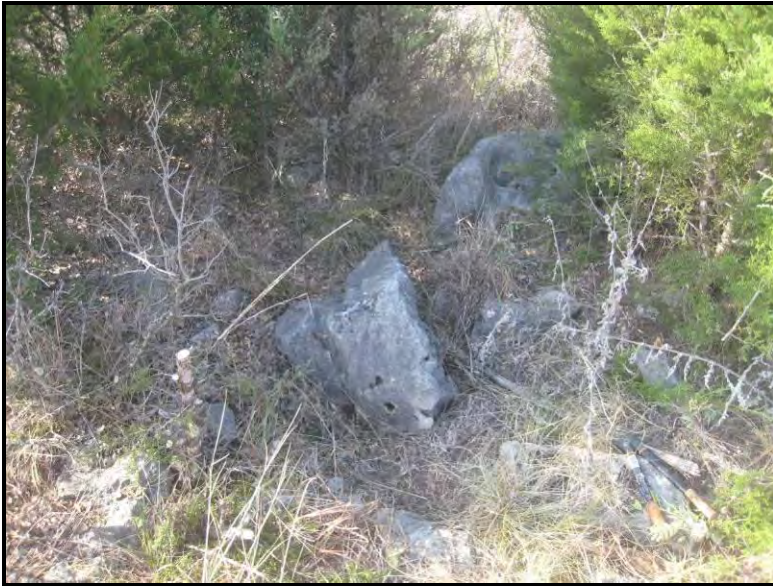
281-035, non-karst closed depressions This is a cluster of three depressions on private property at the northwest corner of Overlook Parkway and US 281 (Figure 54). When initially assessed, their origin was not clear. Excavation took place on 19 August 2010 for 1 person-hour, resulting in the removal of 0.25 m³ (8.8 ft³) of material. Excavation reached hard-packed soil at a depth of 0.35 m (1.1 ft). This feature is likely the result of tree-

Figure 54. Feature 281-035 prior to excavation.

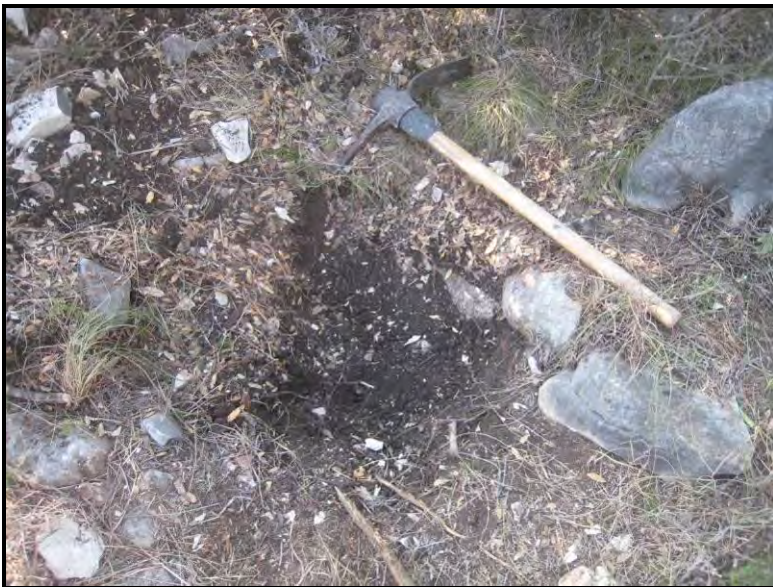
Figure 55. Feature 281-035 after excavation, showing hard-packed dirt floor.

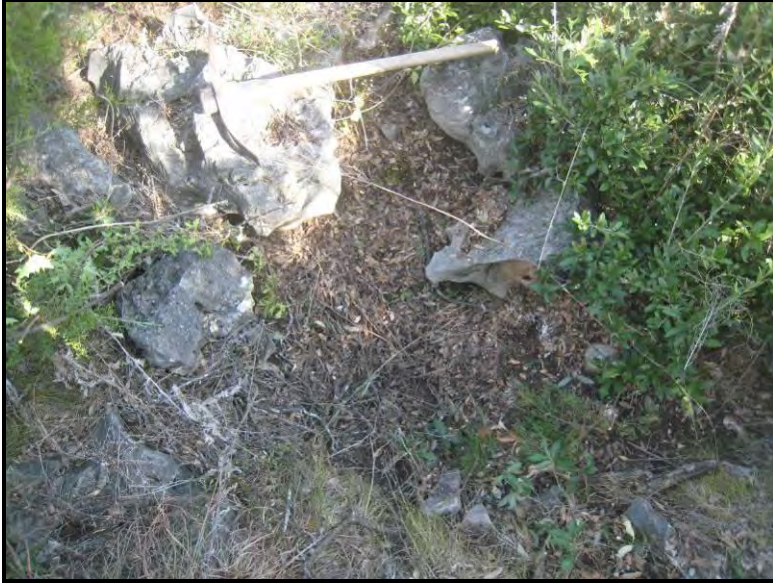
281-036, non-karst closed depression This is a depression located on private property at the northwest corner of Overlook Parkway and US 281. When initially examined, it had a diameter of 1.2 m (3.9 ft) and a depth of 0.5 m (1.6 ft) (Figure 56). It was recommended for excavation, which took place on 19 August 2010. This excavation utilized 1.4 person-hours of effort, and resulted in the removal of 0.1 m³ of material. A bedrock floor was reached with no mesocavernous voids extending from the feature (Figure 57). Post-excitation dimensions of the feature were 1.5 m (4.9 ft) in diameter and 0.75 m (2.5 ft) deep. This feature is likely the result of tree-clearing, not karst processes.

Figure 56. Feature 281-036 prior to excavation.

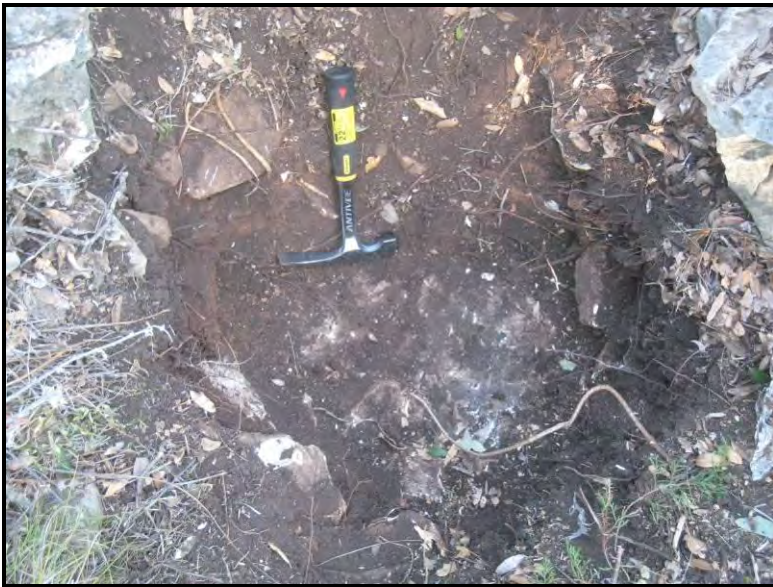
Figure 57. Feature 281-036 after excavation, showing bedrock floor.

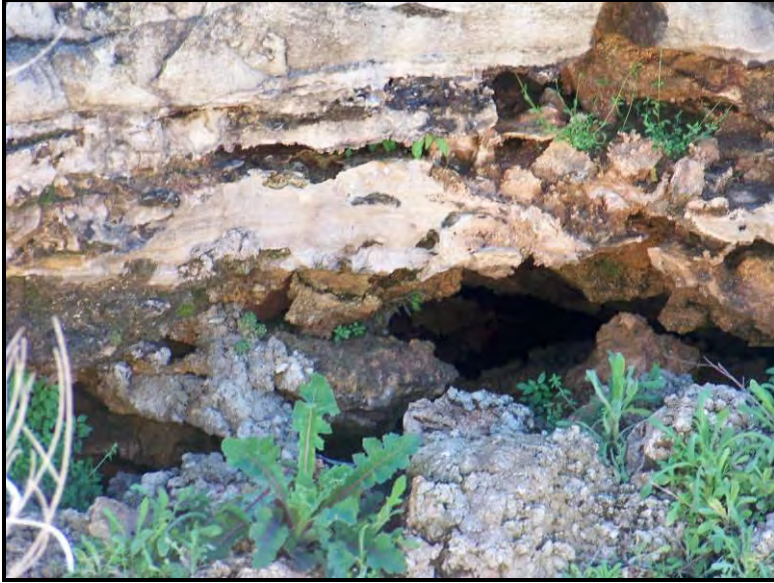
281-037, Painful Crawl, cave This is an enlarged bedding plane cave in a road cut associated with a parking lot outside of the ROW. It was partially filled with concrete, but a low passage could be seen extending into the road cut (Figure 58). Excavation was conducted on 15-16 September 2010. This resulted in 2 m³ (106 ft³) of rocks being removed from the cave using 20 person hours of effort with hand and power tools. This cave is developed in a low, wide bedding plane, and is just tall enough for human entry (Figure 59). The bedrock and flowstone floor is rough, giving rise to the name Painful Crawl (Figure 60). Excavation concentrated on removing bits of rock from the floor and ceiling in order to be able to enter the passage, but did not change the existing footprint of the cave. Excavation continued 10 m (32.8 ft) until dark zone habitat was reached. The entrance to Painful Crawl is at the bottom of a sloping road cut that is 3.5 m tall. It is 1.4 m (4.6 ft) wide and 0.4 m (1.3 ft) tall. After 3 m (9.8 ft), the passage takes a turn to the east, with small bedding plane openings also extending off to the south and west at this turn. After

Figure 58. Feature 281-037, which was partially filled with concrete.

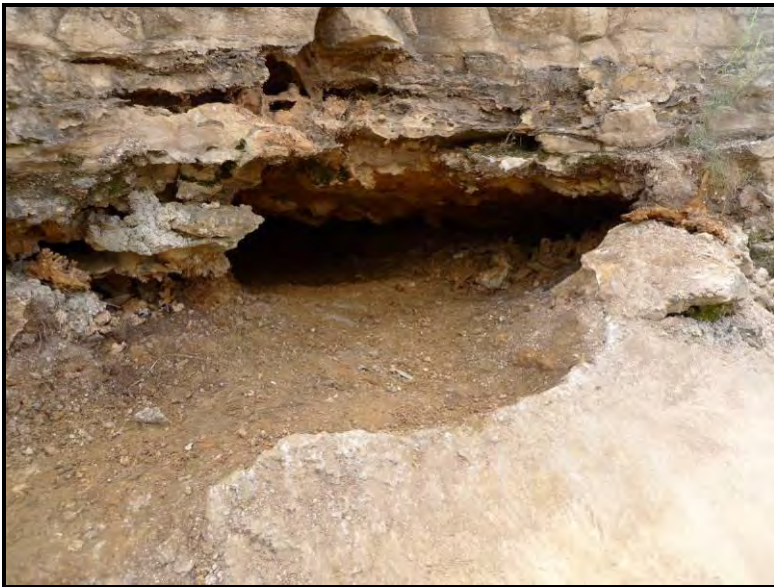
Figure 59. Entrance to feature 281-037 after enlargement by excavation.

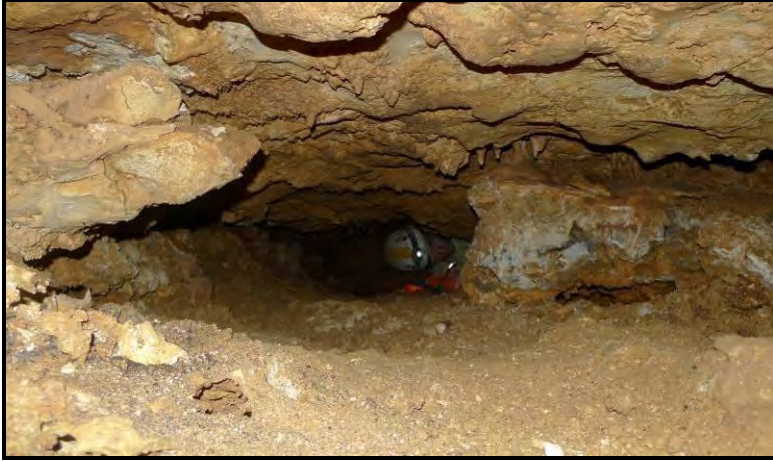
Figure 60. Interior of feature 281-037.

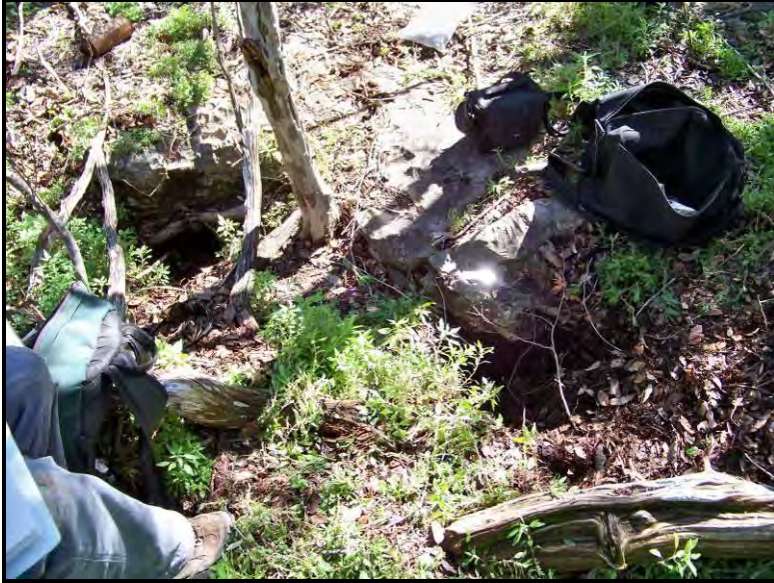
281-038, solutional sinkhole This is a solutional sinkhole that is 2.3 m (7.5 ft) long, 1 m (3.3 ft) wide, and 0.4 m (1.3 ft) deep. It consists of two holes draining under a bedrock shelf with infill of leaf litter and modern soil that is loose to a depth of 0.2 m (0.7 ft) (Figure 62). Excavation was recommended, but ROE for excavation purposes was not granted.

Figure 62. Overview of feature 281-038.

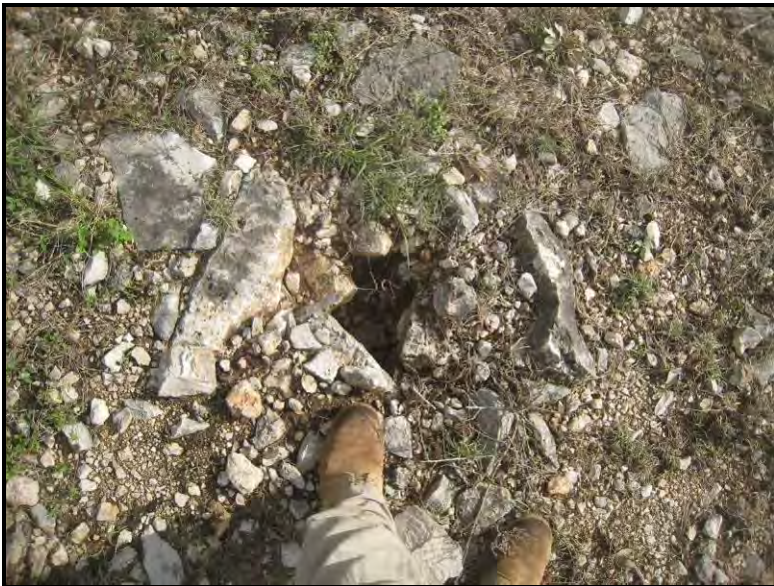
281-039, non-karst closed depression This feature is located on private property on the west side of US 281. When initially located it was a depression 0.25 m (0.8 ft) in diameter and 0.13 m (0.4 ft) deep, with a coarse infill of rocks and modern soils (Figure 63). Excavation was conducted on 10 September 2010. This utilized 0.6 person-hours of effort and removed 0.1 m³ (3.5 ft³) of material. Post-excavation dimensions of this feature were 1.5 m (4.9 ft) long by 0.75 m (2.5 ft) wide by 0.5 m (1.6 ft) deep. This feature is located in a landfill deposit, and is a result of poor consolidation (Figure 64). It is not a karst feature.

Figure 63. Feature 281-039 prior to excavation.

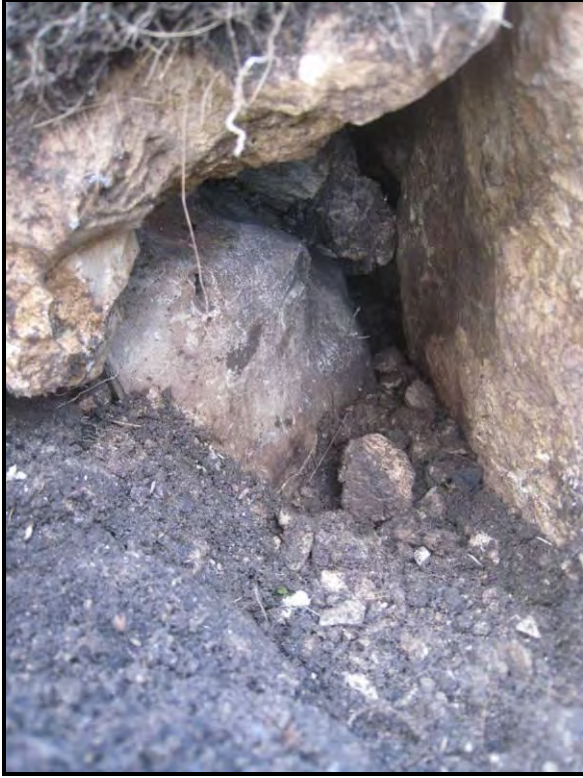
Figure 64. Feature 281-039 after excavation, showing landfill rocks.

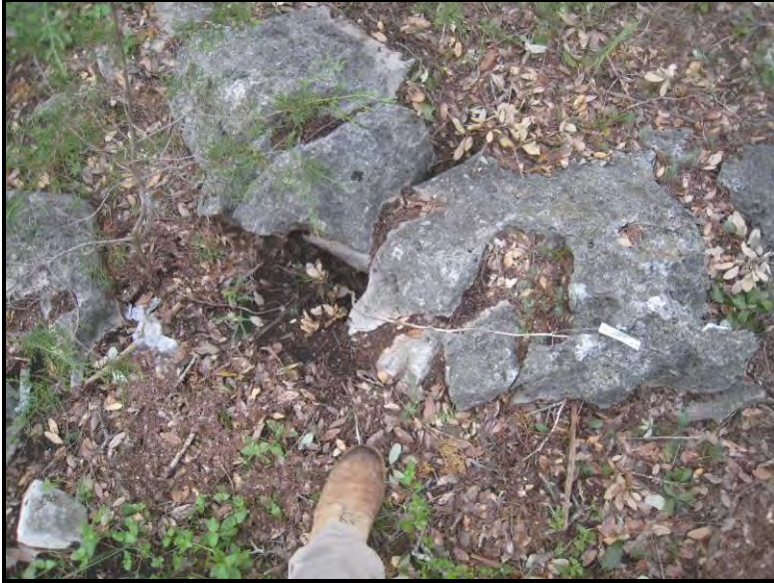
281-040, non-karst closed depression This feature is located on private property on the west side of US 281. When initially located, it was 1.3 m (4.3 ft) in diameter and 0.3 m (1 ft) deep (Figure 65). It had infill of leaf litter and black, modern soil. Excavation was conducted on 10 September 2010, utilizing 1 person-hour of effort and removing 0.2 m³ (7 ft³) of rocks and soil to a bedrock floor (Figure 66). Post-excavation dimensions of this feature were 1.4 m (4.6 ft) in diameter and 0.6 m (2 ft) deep. This feature is erosional in origin, likely the result of bedding plane slumping on a hillside slope.

Figure 65. Feature 281-040 prior to excavation.

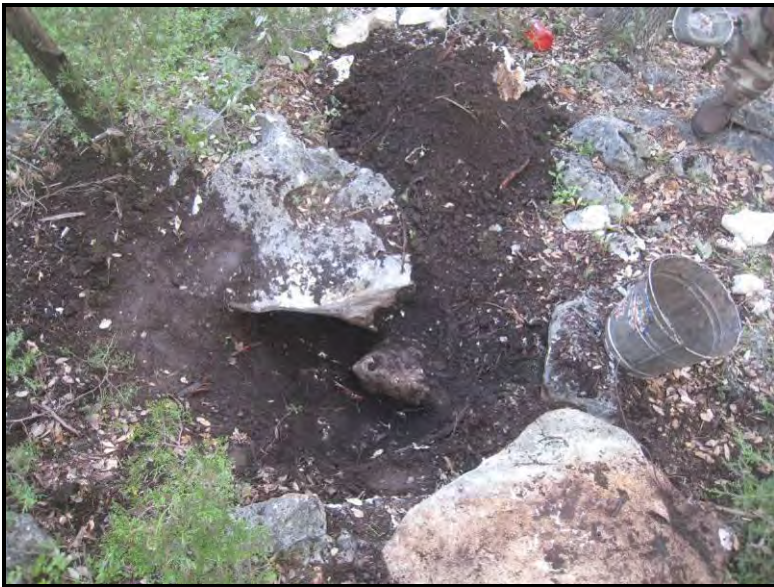
Figure 66. Feature 281-040 after excavation.

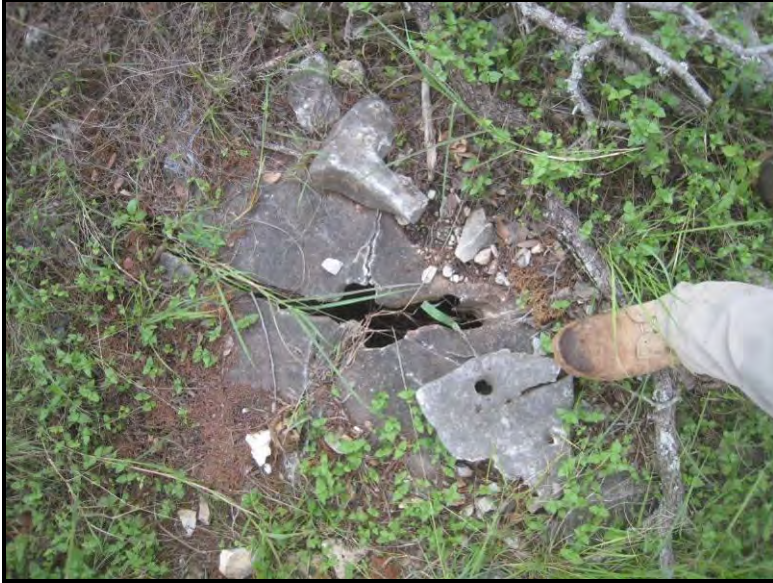
281-041, enlarged fracture This solutionally-enlarged fracture is located on private property on the west side of US 281. Prior to excavation, it measured 0.8 m (2.6 ft) in length by 0.1 m (0.3 ft) in width, and was 0.3 m deep (Figure 67). It contained fine, black sediment of modern origin. Excavation was conducted with a jackhammer on 10 September 2010 utilizing 2 person-hours of effort and removing 0.3 m³ (10.6 ft³) of material. The excavation reached a bedrock floor at a depth of 0.6 m (2 ft), with no mesocavernous voids extending off of it (Figure 68). Post-excavation dimensions of the feature were 1.25 m (4.1 ft) long by 0.75 m (2.5 ft) wide by 0.6 m (2 ft) deep.

Figure 67. Feature 281-041 prior to excavation.

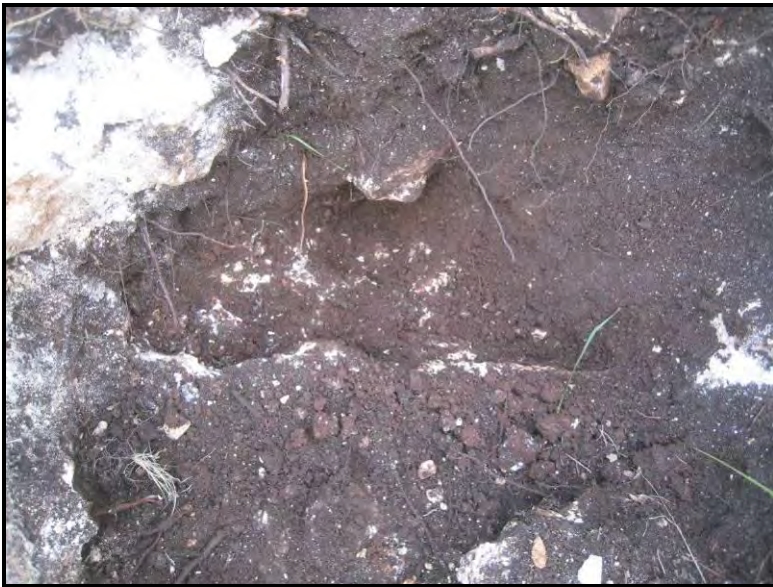
Figure 68. Bedrock floor of feature 281-041 after excavation.

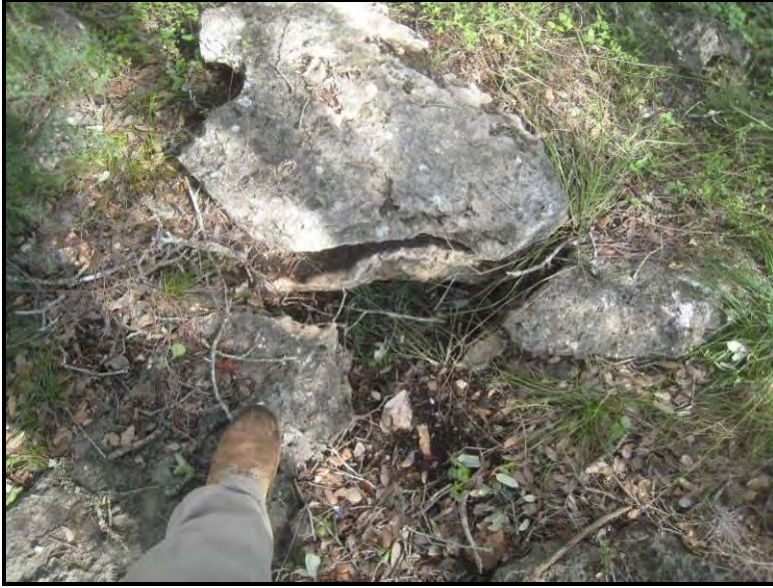
281-042, non-karst closed depression/animal burrow This feature is located on private property on the west side of US 281. When initially assessed, it consisted of two depressions within an area measuring 1 by 2 m (3.3 by 6.6 ft) (Figure 69). It had infill of leaf litter and modern soil that was loose to a depth of 15 cm (0.5 ft). Excavation was conducted on 10 September 2010. This effort utilized 1 person-hour of effort and removed 0.1 m³ (3.5 ft³) of material. Post-excavation dimensions of the largest feature were 0.75 m (2.5 ft) in diameter and 0.3 m (1 ft) deep. This feature is an old, filled animal burrow that goes under a slab of limestone and exits the other side (Figure 70). It is not a karst feature.

Figure 69. Feature 281-042 prior to excavation.
